POLYIMIDE COATED CAPILLARY TUBING: AN ANALYSIS OF END-FACE DEFECTS

BY JOE MACOMBER | MOLEX, LLC.

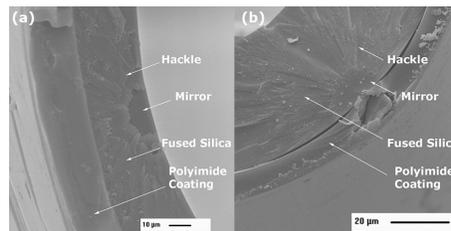
Figure 1: a) End-face of a break caused by an i.d. flaw; dark mirror pattern has a semicircular shape. b) End-face of a break caused by an o.d. flaw; debris that caused failure remains embedded within outer polyimide layer.

Surface flaws on both the glass i.d. and o.d. have been found on many occasions. Figure 1a presents the end-face of a break caused by a typical i.d. flaw. Figure 1b shows a corresponding image of an o.d. flaw. Of particular interest is the pattern of the flaw, which usually comprises two components referred to as the mirror and hackle. The mirror portion penetrates the surface to a depth of 5-10 μm and is semicircular in shape. It is smooth in appearance and is formed when the surface is initially damaged. When the capillary is subsequently stressed, typically by bending, this mirror-smooth flaw propagates outward in a series of jagged fractures referred to as the hackle. This fracturing ultimately results in breakage of the tubing. This mirrorhackle pattern can be seen in both figures.

The most common cause of i.d. flaws is glass debris from cleaving; the importance of which has been discussed previously (1). Introduction of debris from fittings, connection lines, or unfiltered solvents is less common, but has been verified on occasion. Debris is also the most common cause of o.d. flaws. The break shown in Figure 1b was caused when debris penetrated through the protective polyimide coating and contacted the glass surface. Elemental spectral analysis confirmed that the embedded debris was a piece of fused silica, most likely from a dirty work surface. Cleanliness of the work area and any equipment that contacts the capillary is critical (2). Determination of where the failure began greatly aids in taking the appropriate action to minimize breakage.
