# BRITTLEBACK IN POLYIMIDE COATED CAPILLARY TUBING

BY JOE MACOMBER | MOLEX, LLC.

**Polyimide coated fused silica capillary tubing is widely used in the separation sciences. In some instances a condition called brittleback can appear in the tubing. Its causes and remedies are discussed.**

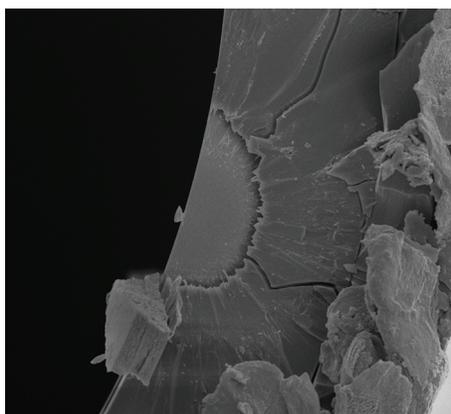
Capillary tubing develops brittleback because the internal surface has been mechanically damaged by debris. When the tubing is subsequently stressed by being bent or handled, it breaks. The most common debris sources are shards of glass from a poor cleave or an earlier break, metal particulates from fittings or valves, particulates/ precipitates from unfiltered solutions or particulates from dirty work or glassware surfaces. This debris is driven down the tubing by gases or liquids introduced into the

tubing. The higher the head pressure and the larger the internal diameter, the further the debris can be driven down the tubing. Figure 1 is a good example of a brittleback event. End face analysis can be performed for verification and can sometimes clearly identify the debris source (1).

Figure 1: Brittleback Example - this glass debris induced break occurred ~35cm from the end of the tubing. The glass debris is less than 4µm in size and is typical of debris from a poor cleave.

Once brittleback develops, the first sign is an unwanted break, which only exacerbates the problem due to the additional glass debris generated. The best course of action is to remove and discard the damaged section. This is done by moving down the tubing and performing a good cleave. A starting point is 50cm, but Polymicro suggests moving 1m if possible. This is repeated as needed.
